# NSLS-II BEAM APERTURE SLIT VIBRATION STUDIES

C. Spataro, C. Amundsen, H. Bassan, S. Sharma  
Brookhaven National Laboratory, Upton, NY 11973 USA

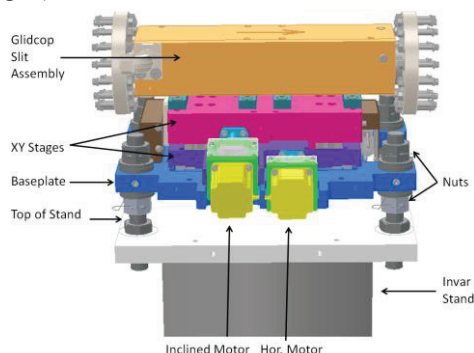
Figure 1: NSLS-II Frontend Slit Assembly.

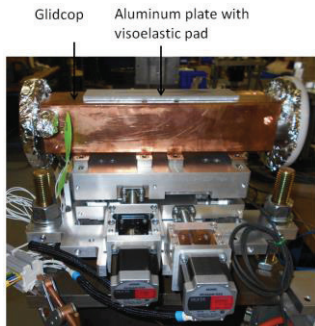
out the vibrations (Fig. 2). This reduced the peak vibration levels but at the expense of broadening the bandwidth. The runaway vibration problem was still not resolved.

Figure 2: Slit assembly with viscoelastic pad.

An experiment was then performed in which a viscoelastic pad was added to the top of the slit to help dampen

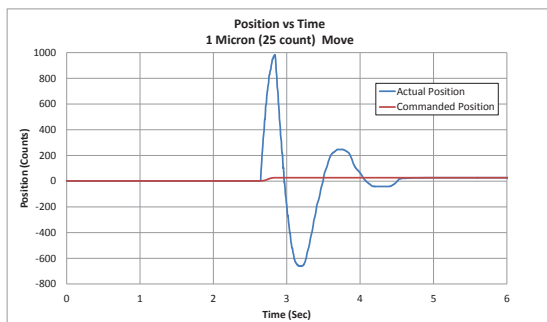
Current tuning of the motors followed by the PID loop tuning was done to get a better response. It was found that when moving the motor by a small number of encoder counts (for instance, 25 counts, which is equivalent 1 micron in position) the motor actually moved up and down over one thousand counts ( $\pm 40$  microns) before arriving to the desired position (Fig. 4).

Figure 4: Actual and Commanded Position vs Time.

The motors were re-tuned and this reduced the unwanted excursion to 14 microns, which is still large but much better than the original tuning.

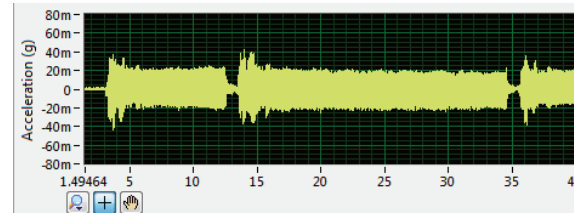
A large factor in the vibration was the default motor velocity. Tests were performed at various velocities. It was found that there was a linear correlation between vibration levels and the default motor velocity. After numerous rounds of tests, a reduced velocity of 1/3 of the default velocity was deemed to be a good compromise which reduced the vibration levels by a factor of three (Fig. 5 and 6).

Figure 5: Acceleration vs Time - Default Velocity.

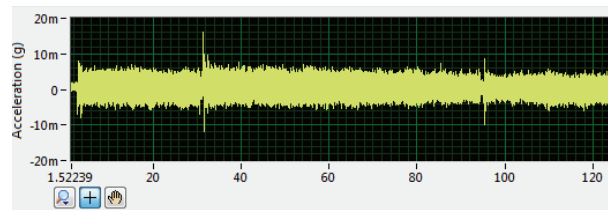
Figure 6: Acceleration vs Time - 1/3 Default velocity.

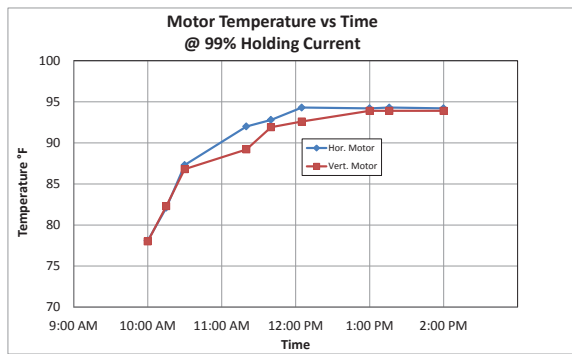
Figure 7: Motor Temperature vs Time.

Temperatures reached equilibrium within two hours and were within specifications. This meant that the holding current could be increased without overheating the motors.

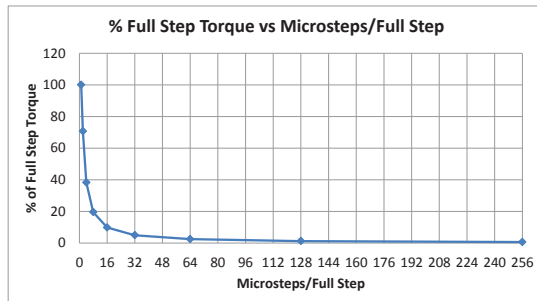
The intermittent nature of the problem is likely to be caused by the reduction in the motor torque when microstepping is used. At the 32 usteps/step setting of the motor, the torque drops to 5% of its rated value (Fig. 8).

Figure 8: % Full Step Torque vs Microsteps/Step.

Depending on the exact position in relation to the motor steps, the torque will vary, so in some microstepping positions the torque is higher and the motor does not squeal, where as in other positions, the torque is lower and the motor starts to squeal. While reduced torque has been established as the cause of motor squealing, the sequence of events in terms of motor current, pulse counts, and position, is still under investigation.

It is now planned to increase the holding current and reduce the number of micro-steps for the inclined-axis motor. If the motor squealing persists then 90° worm-gear reducers will be used to increase applied torque to the stages.
