FRONT END PHOTON SHUTTER WATER LEAK TO VACUUM AT THE CANADIAN LIGHT SOURCE

G. Henneberg*, G. Barkway, M. J. P. Adam, Canadian Light Source Inc., Saskatoon, Canada

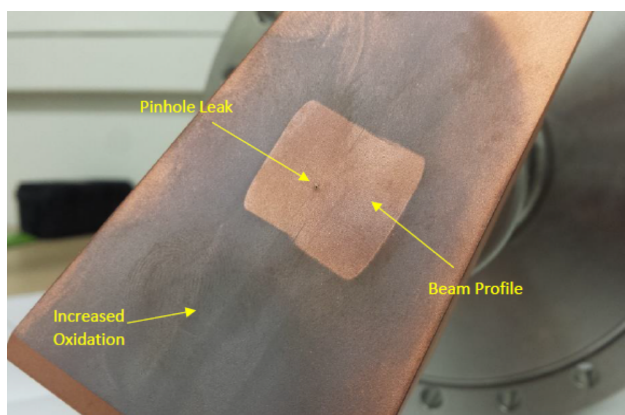
A collaborative decision was made to wait to find the exact location of the leak. The mechanical technicians first activated a scroll pump in an attempt to pump down the affected section. Water was discharged from the exhaust of the scroll pump, which indicated the water leak. After determining that the leak had originated in the HXMA FE, the technicians identified which components may have failed. By the afternoon, they had discovered a small pinhole leak on the absorber head of the first HXMA photon shutter (Fig. 1).

Figure 1: Illustration of the pinhole leak discovered on HXMA PSH1. Leak location is aligned precisely with water jet location of the tube in tube cooled absorber.

through the head of the absorber. The leak developed at (or very near) the centre of the absorber's face (Fig. 1). There are six other photon shutters that employ this exact same design currently in use at CLS. There are also 12 photon shutters that are derivatives of this design. Their cooling system and operational parameters are almost identical. Therefore, it is necessary to identify why failure occurred, how it can be prevented, and/or if other components are at risk to fail.

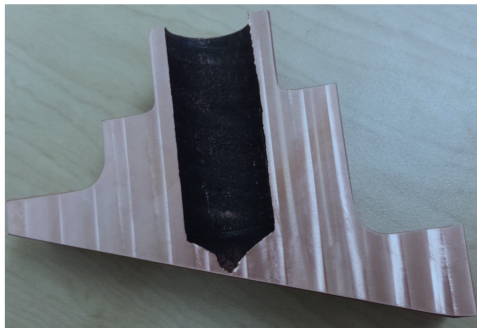
Figure 3: Section cut of failed PSH1, used to investigate extent of damage and location of erosion.

suspected to be degradation of the copper walls due to corrosion, erosion, or impingement damage. Operating conditions of HXMA PSH1 (at >7.12 m/s) exceeded CLS's maximum flow velocity standard of 2.5 m/s [1]. The typical maximum

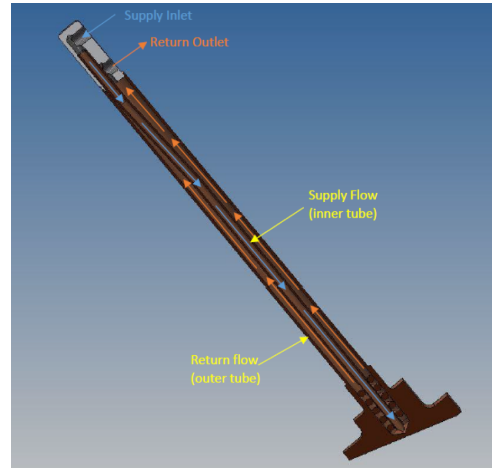
Figure 4: Illustration of the tube-in-tube configuration of PSH1. Cooling water enters from the inner tube and exits the outer tube passage.

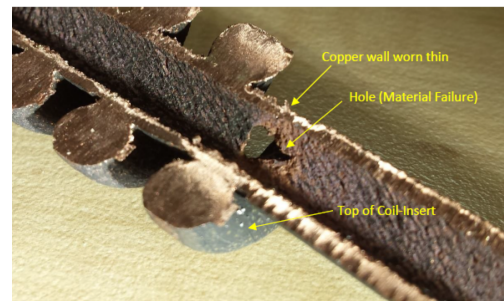
At the very top of the coil, a hole on the wall of the inner tube formed, allowing water to escape into the return flow without travelling to the base cavity. The hole is roughly 4 mm long and 3 mm wide. The hole sits directly beneath the end of the coil (Fig. 5). There is significant material degradation around the hole and the pipe wall is very thin.

Figure 5: Section cut of eroded inner copper tube.

The mechanism causing failure of the sidewall (Fig. 5) is not well understood. Its effect on the system is difficult to determine for the following reasons:

It is clear, however, that the location that the hole formed was unique. The hole sat right at the end of the coil, near a change in diameter on the outside of the tube. The pattern of erosion/corrosion on the inside surface changed abruptly on either side of the hole.

The hole may have formed for a multitude of reasons. There may have been localized turbulence as the fluid exited the spiral, increasing the rate of erosion-corrosion. Faulty brazing/soldering work between the coil insert and the tube may have weakened the tube wall. The hole may have formed along the edge where the tube diameter changed creating a larger stress concentration.

To prevent further degradation in similar photon shutters, flow rate should be evaluated to determine if a lower velocity is adequate (reducing the likelihood of similar HXMA PSH1 failures). Continuing to operate under current conditions may lead to further absorber failures, water leaks, and vacuum leaks. Due to damage they may have sustained operating under similar operating conditions, PSH of this design currently in service should be either examined or replaced at the CLS's earliest convenience. PSHs installed during the Phase II expansion are similar in design and operating conditions; flow velocity settings should be reviewed, but these absorbers may not need replacement.
