CLSI BMIT'S SUPER-CONDUCTING WIGGLER CRYOGENIC SAFETY IMPROVEMENTS*

L. Lin[†], T.W. Wysokinski, Canadian Light Source (CLS), Saskatoon, Canada

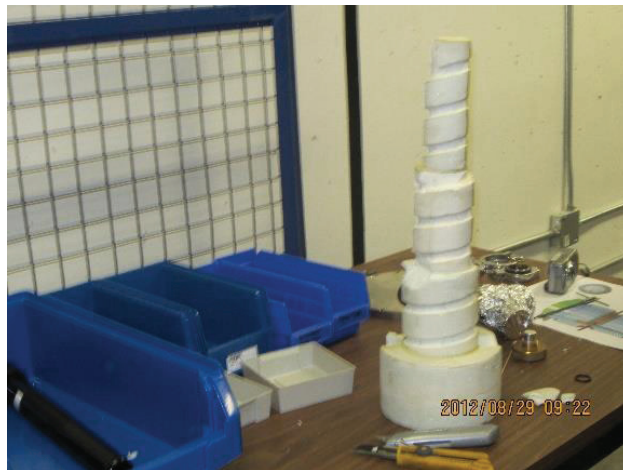
The air leaking into the cold space eventually froze at the wiggler's vent path – see Figure 1, separating the cold space from the room temperature gas space. The vent path was made of a spiral channel cut in a foam insulation installed in wiggler's central throat. The vent path/channel was about 15 mm wide and 10 mm deep, connecting dewar with the top casing where the vent outlet was located. The pressure relief valves and the rupture disk were both connected to this vent outlet. As a result of the blockage, the helium gas was not able to relief through this vent path during liquid helium refilling procedure, at the same time the pressure gauges were not showing properly the cold space pressure - a safety concern was raised.

Figure 1 Spiral vent path cut in the insulation foam.

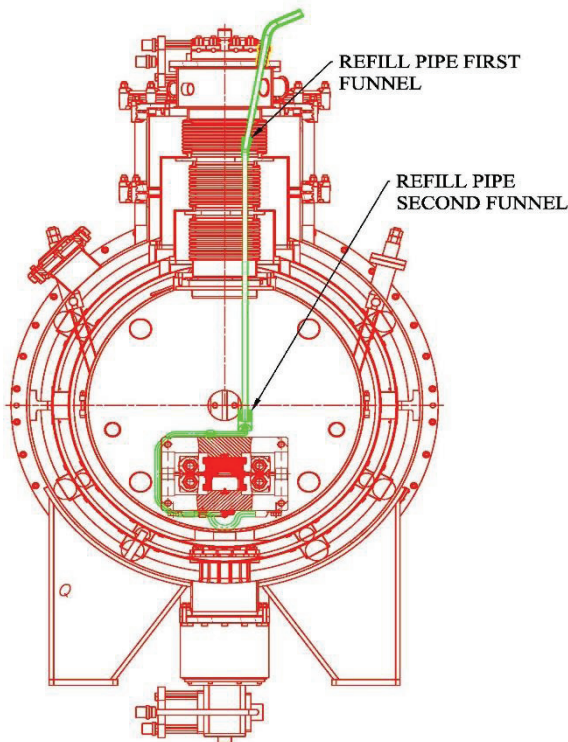
The wiggler refill path is constructed with three-sections: external LHe transfer line is inserted into the wiggler through the top section and sits on the first funnel. The middle section is made of an internal LHe transfer tube that leads LHe to the second funnel located on the top of the magnets. The bottom section is a bended LHe transfer tube built around the magnets that discharges the LHe to the bottom of the cryostat (see Figure 2). Ice has formed at all three refilling path sections. A heated copper pipe was used to successfully remove the ice at the top and the middle sections. However, if ice-block formed at the second funnel or the bottom section it was not removable without the warmup. When attempting to refill with vent path blocked, LHe would boil-off at the transfer line sections and at the top section of the cryostat. Pressure therefore would build up until refill tube was removed. A large amount of cold helium gas came out from the cryostat at high pressure at this point, cryogenic hazard occurred.

Figure 2 BMIT's wiggler initial refill path.

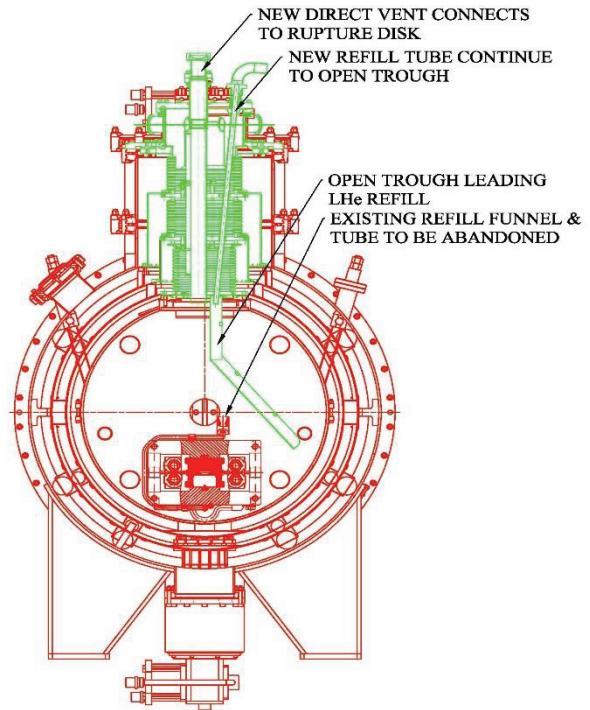
Figure 3 A new vent path & refill path.

- Rupture disk was replaced with the new one and equipped with rupture indication signal.
- 2. Major modifications at the wiggler vent path and refill path – made by BINP group.
 - A separate and direct vent path was added - 1.5" DIA pipe connected the wiggler cryostat cold and warm space through the central throat. This hollow pipe runs from the top of the cryostat to the new rupture disk located on the top of the wiggler and provides a barrier free direct exhaust for emergency pressure relief.
 - The vent path for the pressure relief valves uses improved spiral channel at the foam insulation.

- Two heaters were added into the pressure relief vent path to the two narrow points of the central throat - at the two copper flange plates (20 K & 60 K) to mitigate potential ice built up.
- A new LHe refill path was constructed to replace the existing one with two sections. The top section is a single tube runs straight into the bottom section - an open trough that leads the LHe to the lower side of the wiggler cryostat (Figure 3). This change is to eliminate potential ice blockage at the bends.
- Liquid helium transfer line was permanently connected to the wiggler – This became a huge problem as discovered later.

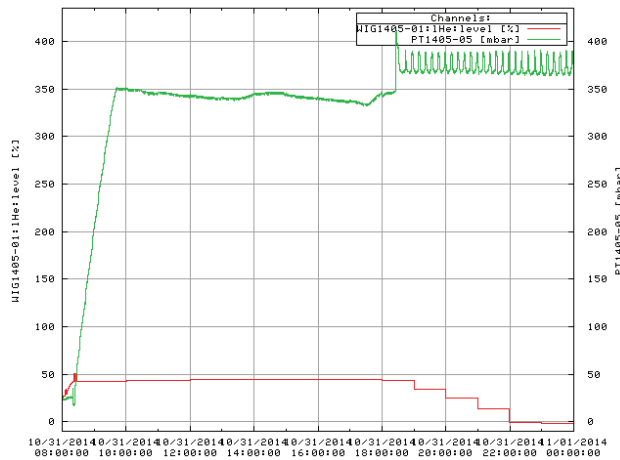
1. The wiggler experienced thermal acoustic oscillation problems at refill after the upgrades [4]
- The problem was discovered at the first refill: pressure at the cryostat built up to 350 mbar two hours after the refill was completed and stabilised for about 5

hours then started oscillated. The LHe started evaporating right after and the LHe level in the cryostat dropped from 43% to 0 in less than 2 hours (see Figure 4).

Figure 4 Pressure & level changes at oscillation.

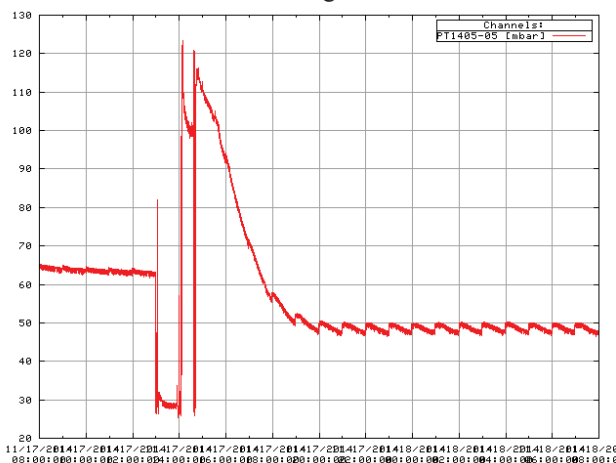
- The second refill repeated and confirmed the same problem: 7 hours after the refill, pressure built up to 350 mbar and stabilised for about 4 hours then started oscillations again.
 - BINP indicated that the thermal acoustic oscillation was most likely caused from the long, warm, LHe transfer line that was connected to the cryostat.
2. Several steps performed to fix the thermal acoustic oscillation problem
- LHe transfer line was removed. Pressure at cryostat built up to below pressure relief pressure (350 mbar) and was able to drop and stabilized. Small oscillation was still shown (see Figure 5). The above atmosphere pressure at no load condition indicated that heat load increased at this new configuration.

Figure 5 pressure change at LHe transfer line removed.

- A dummy plug made of G-10 FR4 (epoxy the surface) installed at the LHe refill tube to close the opening in the central throat insulation.

- Supper insulation disks designed and installed inside of the 1.5" DIA exhaust pipe using multilayer insulation to reduce radiative and convention heat-loads.
3. End results
- The secondary vent path provides a barrier free safety relief to the wiggler cryostat with super-insulation disks to reduce the heat leaks.
 - Pressure at the wiggler cryostat is able to run back to sub-atmosphere to about -160 mbar after the upgrades with no SR heat-load.
