# Status of Solaris Synchrotron

*Krzysztof Guła*  
On behalf of RF section

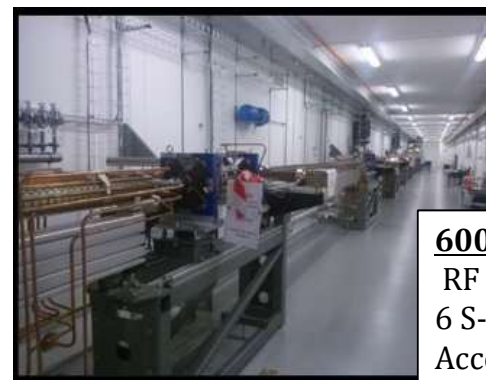
## 600 MeV Linac

- RF Thermionic Gun
- 6 S-band 2998.5 MHz acc. structures
- Accelerating gradient 20 MeV/m
- 3 RF Units & SLED cavities
- Dog-leg vertical transfer line
- In operation since Dec. 2014

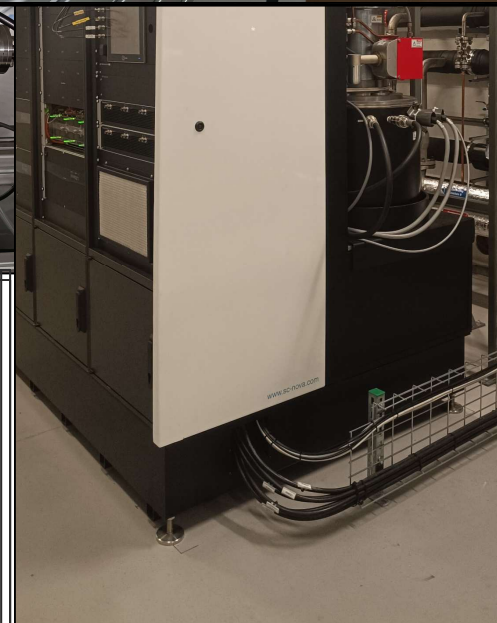
- 3GHz CW generator
- Phase shifters
- Thermionic Electron Gun
- Pulsed pre-amplifier
- Klystron Thales with modulator (for GUN)
- Chopper 100MHz
- SLEDs, Waveguides, etc.
- Accelerating structures

RF SLEDs for accelerating structures Gun (KOD) k03  
 Modulator, 200kV, 100A, 100Hz  
 Type: SWA1000-03  
 Power: 100kW  
 Frequency: 100MHz  
 Beam current: 20mA  
 Beam energy: 7MeV  
 5 cavities

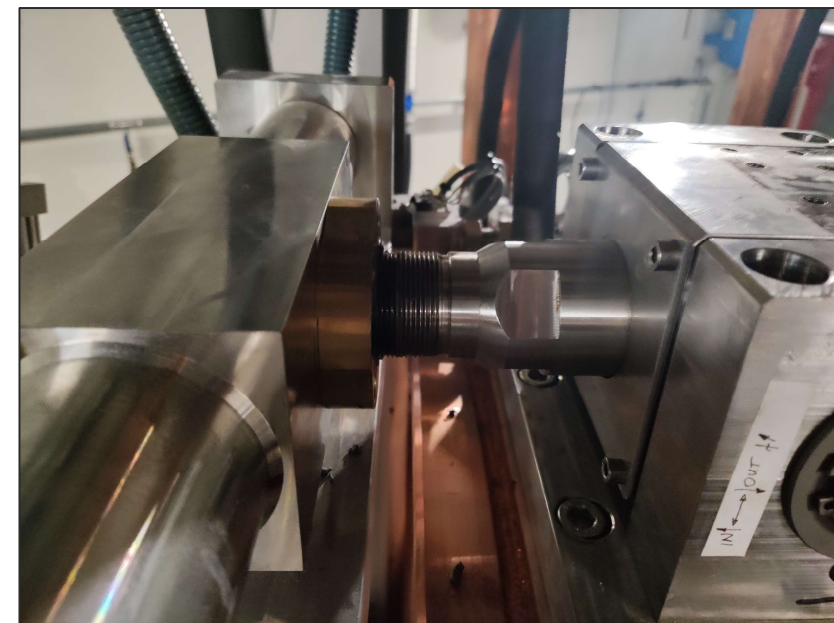
- Cicrulators
- Transmitter amplifire modules
- Main cavity motor gear
- Spare LLRF – NUTAQ unit

The first stage, more failures occurred in the AFT circulator. Intake lines are damaged in respect to overall condition. Many particles are found shown. We scheduled to AFT for repair and to provide a new filter. The bearing was inspected for any problem. The bearings have been replaced but they failed a 1000 rpm test with the new one. We are repairing the operating line at 1 AFT circulator and 1 MT circulator, however, both AFT circulators have damaged ferrite material.

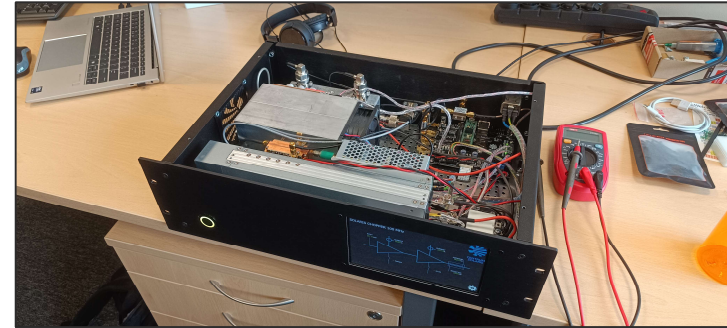
RF Chopper

Pulsed power Amplifier 100MHz – 1kW.

Due to a failure of the operational amplifier (chopper), despite quick repair, the decision was made to build a new one based on an in-house design, using key components

NXP MRFE6VP61K25N

such as LDMOS power transistors compatible with other equipment. This will ensure standardization of spare parts inventory, and given the significant cost of transistors, building a new amplifier is also economically justified.

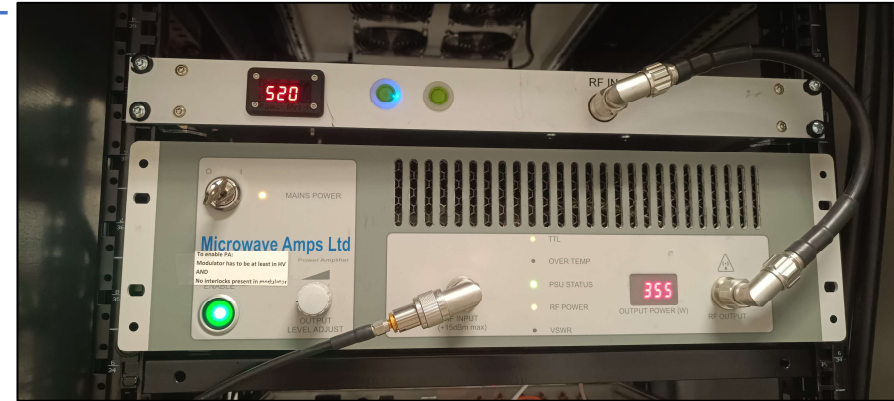
Pulsed Power Measurement Device for preamplifiers at Modulators. The goal of this project is to obtain accurate RF power values feeding the modulators. Due to the pulsed nature of the signal, the existing measurement in the preamplifiers themselves is neither stable nor accurate. Precise measurement of the power incident on the klystrons will allow for accurate drive control, which will affect their lifespan. The prototype has been completed and installed. It operates correctly. Work on the final version is 90% complete.

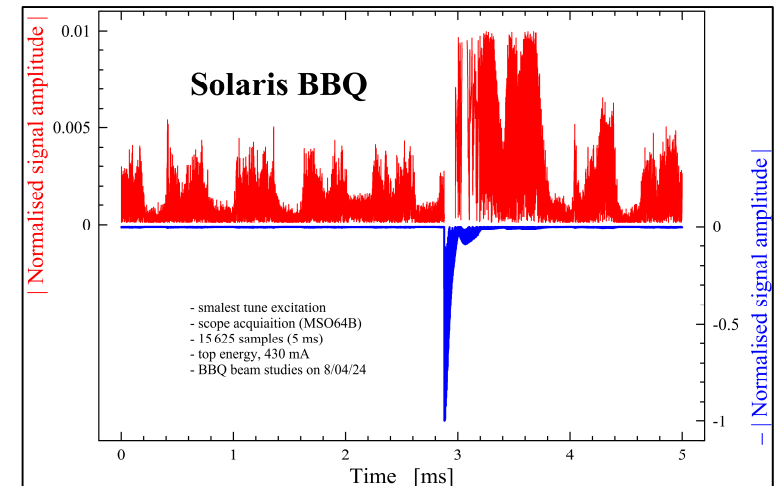
### BBQ Tune Measurement

BBQ – Tune Measurement – This project was developed as a modernized continuation of the synchrotron tune measurement system, with no impact on the beam. It was realized in collaboration with Marek Gasior from CERN. The project was successfully completed; however, due to the implementation of BBB Feedback, which uses the same stripline, it is currently not in use, and tune measurement is provided by BBB FB. Nevertheless, the project resulted in continued collaboration with CERN in the construction of a short diagnostic beamline for testing BPMs for CERN's needs.

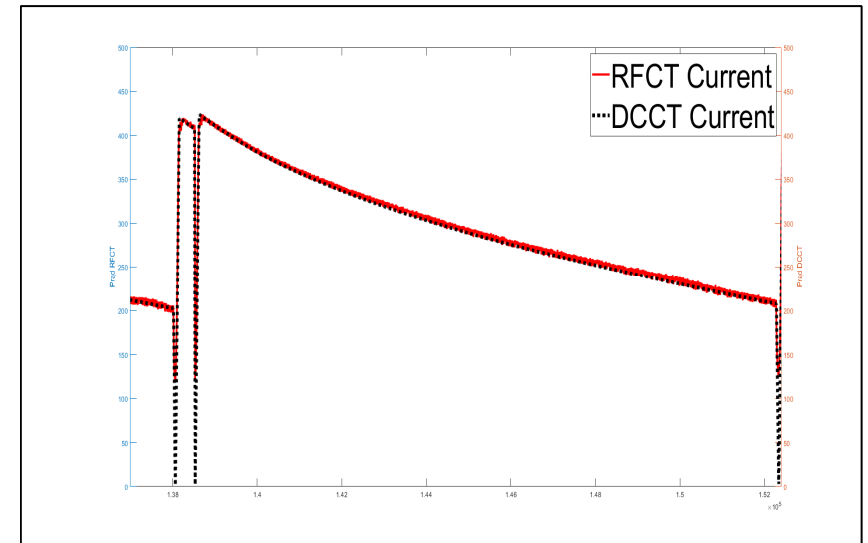
RFCT (RF Current Transformer) – an in-house project initiated by an intern from the diagnostics and electronics section in collaboration with the RF section. The project is completed but still in the testing phase due to unstable behavior during injection and consequently unrepresentative results. Under stable conditions, after beam ramping, it operates correctly.

Compare DCCT and RFCT beam current

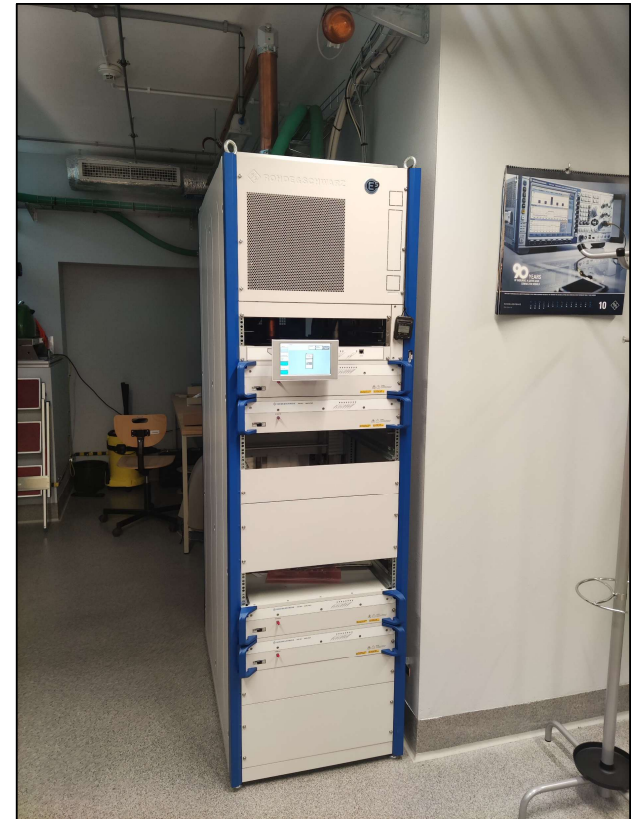
We are in the process of building an advanced RF laboratory that will include the same components as those operating in the synchrotron: LLRF with peripherals, 30kW transmitter, circulator, 100MHz resonant cavity, and cooling system. The components used will also serve as backup for those operating in the storage ring.
