# **ALBA Status Ferran Fernandez**

XXVII ESLS Workshop ALBA Status November 28<sup>th</sup> 2019

# Layout

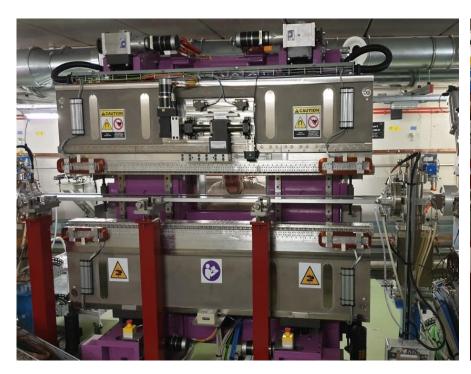
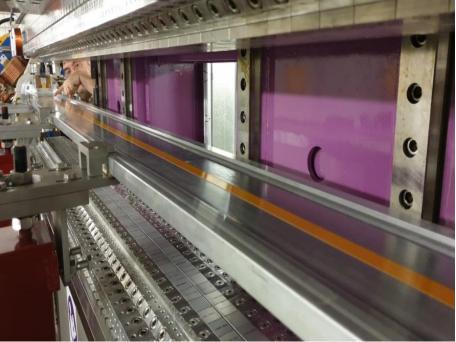
- Correcting coils made of strips glued to vacuum chamber
- Look Up Tables to avoid tune and betabeating (avoid disturbances to rest of the BLs)

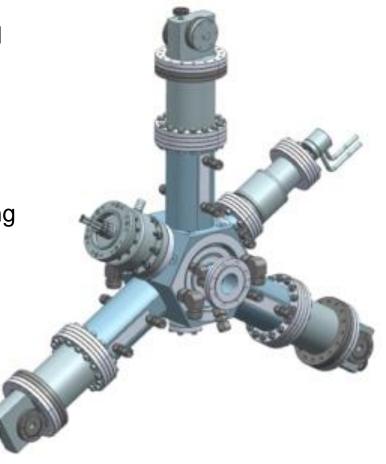
- 4 cavities at 1,5MHz
- Active (20kW)

- Same design as SR RF cavities scaled 1/3
- HOM Dampers with N transition to extract power of HOM and to avoid ferrites + brazing
- Cavity Prototype
  - Sept '19 signed contract with AVS
  - Delivery expected in spring '21
- Transmitter (20kW SSA)
  - Soon...
