# THE INFLUENCES OF MATERIAL PROPERTIES TO MICRO DAMAGES ON VACUUM CHAMBER CF FLANGES

S. Vilcins, M. Holz, M. Lemke, D. Nölle, Chr. Wiebers, DESY, Hamburg, Germany

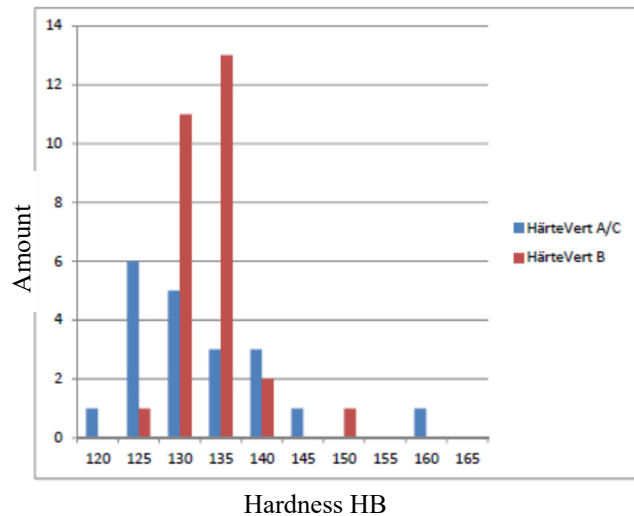
One type A/C chamber with 164 HB had the highest value. The minimum value was 122 HB. The average of 20 chambers type A/C was 135 HB. The type B vessels didn't show different results. The minimum value was 129 HB and one chamber had a maximum of 151 HB. The average of type B was 137 HB.

Diagram 1: Show of hardness comparison between type A/C and B.

Moreover the hardness of the raw material was checked, too. The results were in the same bounds of the chambers. Minimum value was 141 HB and maximum was 152 HB. The measurements have been done at DNV GL in Hamburg (see Diagram 1).

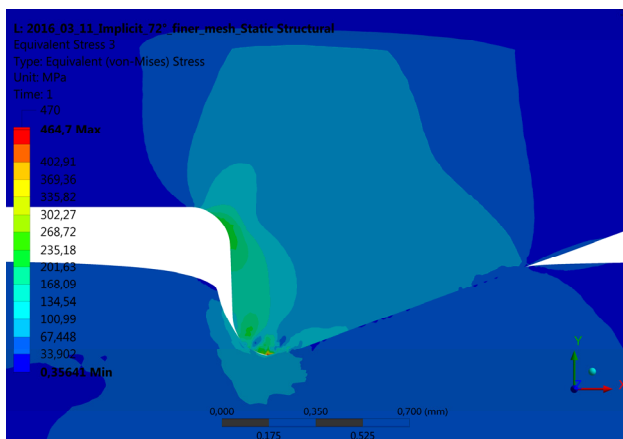
The following Figures 13 and 14 show a comparison with equal scaling between the two geometrical variants for the CF-flanges. In general the stresses in the sealing are nearly identical whereas the stresses in the CF-flanges are different in detail. The edge of the 72°-flange has more concentrated stress-zones compared to the 90°-flange with more homogeneous stress distribution. The stress level up to 470 N/mm<sup>2</sup> is a direct result of model-problems/a singularity in the contact zone. Stresses up to a level of 320 N/mm<sup>2</sup> are feasible. The 90°-flange has more "material connection" to the rest of the flange to withstand the forces due to tighten the flange screws.

Figure 14: This picture show stress in the DESY 72° knife edge zone.

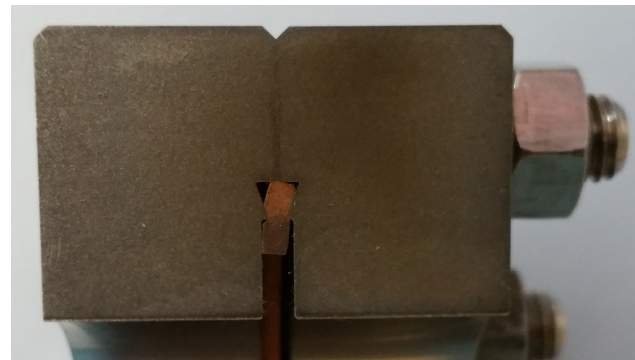
The disadvantage of Conflat flange connections is that they need much more attention and special care during manufacturing and assembly processes. In order to obtain reliable flange connections, the sealed diameter of the mating knife edges must be absolutely equal to avoid the umbrella effect or staggering of gasket, as reported by Unterlerchner [13]. In the following Figure 15 the umbrella effect is documented. This negative effect produces untitled vacuum leaks.

Figure 15: This picture show a gasket can be twist during assembling.

For customer designed Conflat flange applications a few measures and tolerances have to be attended. The knife edge diameter should better within 0.1 mm, the knife edge radius not bigger than 0.2 mm and the eccentricity should be held be within 0.1 mm related to the flange middle axis. The recess for the gasket should be tolerated to within 0.05 mm related to middle axis of the flanges. The sealed surfaces must not have any marks, scratches or dumps. And the sharp tolerance of sealing surfaces should be within 0.05 mm. And finally the knife edge angles should not be smaller than 90° (leaned to ISO/TS 3669-2 standard).
